# **WATER DAMAGE/MOLD INVESTIGATION**

**Registry of Motor Vehicles  
490 Forest Avenue  
Brockton, Massachusetts**

Prepared by:  
Massachusetts Department of Public Health  
Bureau of Environmental Health  
Indoor Air Quality Program  
January 2020

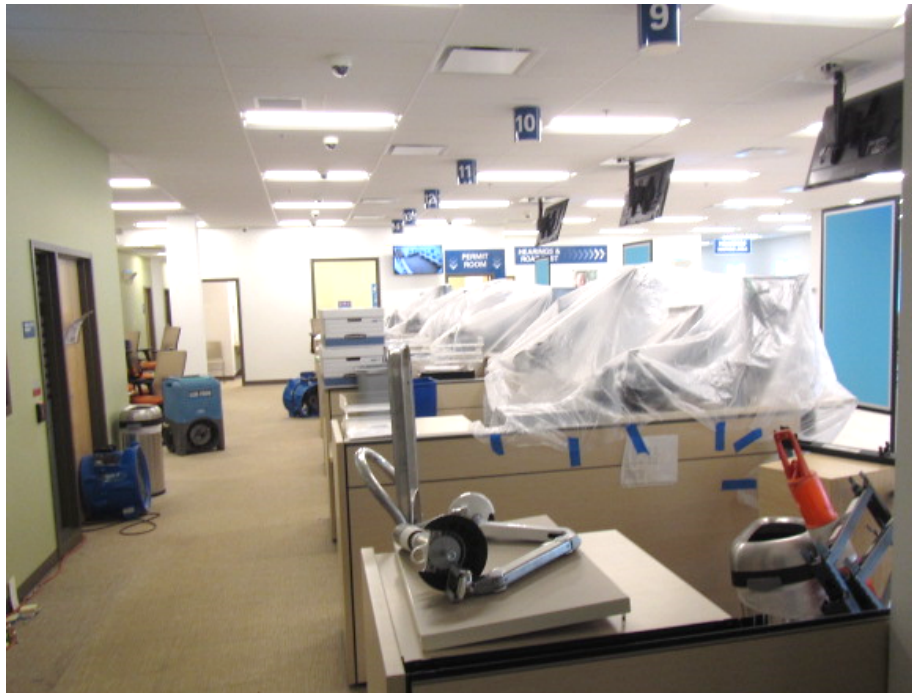
**Picture 1**

At the time of the initial MDPH/IAQ visit on January 24<sup>th</sup> remediation activities (removal and drying of water-damaged building materials) were fully active (Pictures 1 through 5). At the time of the follow-up visit on January 27<sup>th</sup>, all water-damaged materials had been either removed or dried and no visible mold/associated odors were observed/detected (Pictures 6 through 10). In addition, relative humidity measurements indoors ranged from 24 to 27%, which was significantly lower than outdoors (38%), which shows that there were no lingering moisture issues within the building.

**Drying equipment (fans, air movers) and equipment protected/covered with plastic**

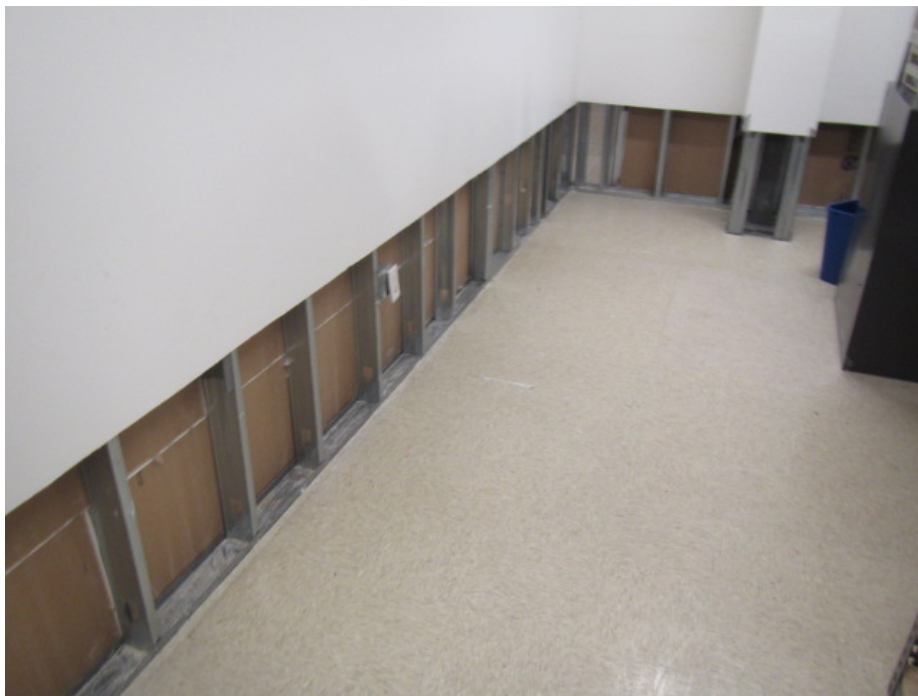
**Picture 2**

**Wet drywall removed**

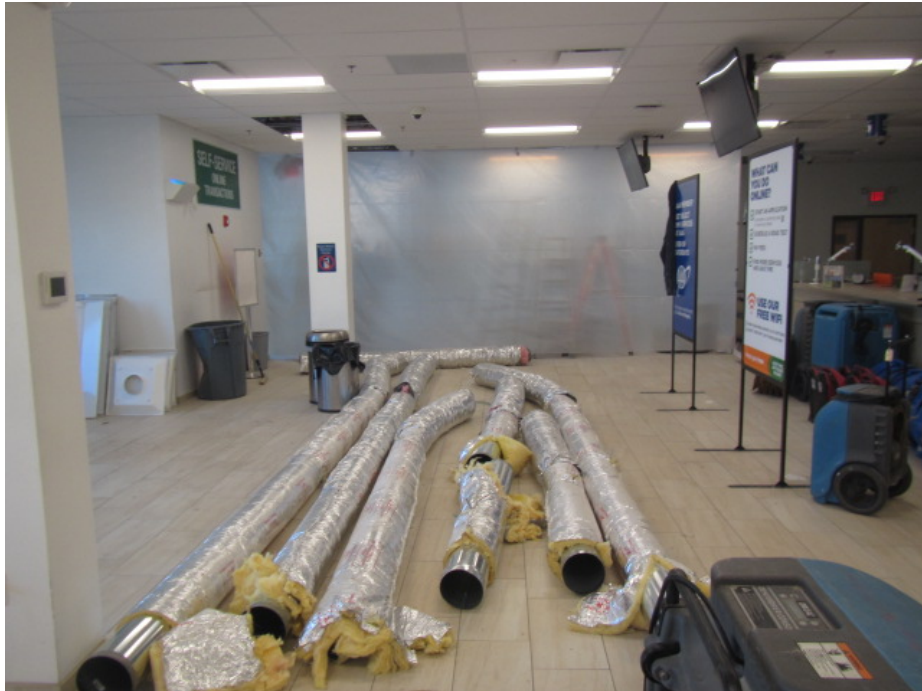
**Picture 3**

**Ductwork removed, demolition (area where leak occurred) sealed off**

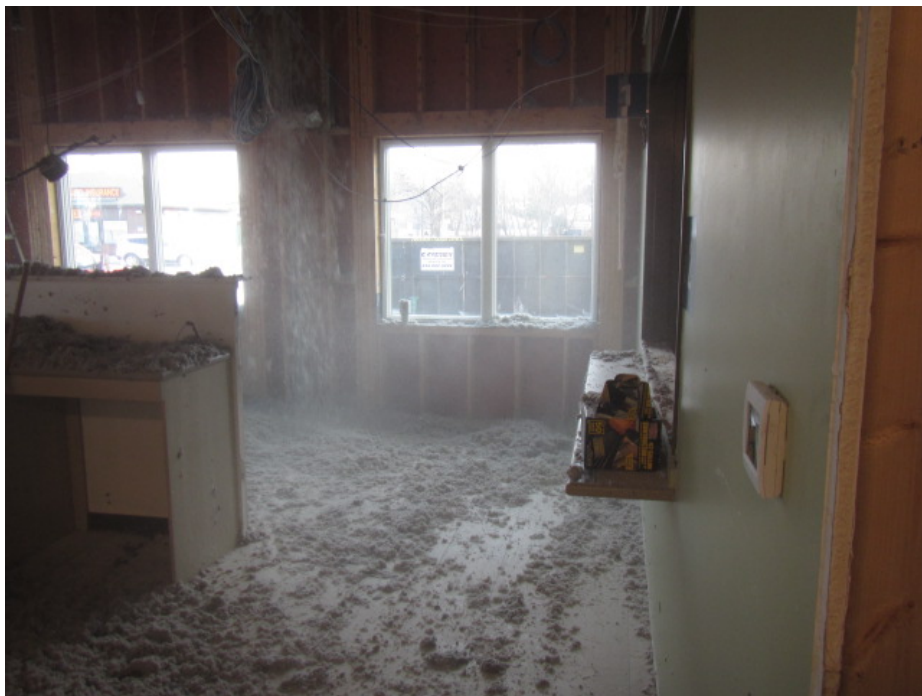
**Picture 4**

**Complete ceiling/wall/insulation removal of affected (east side) area where leak occurred**

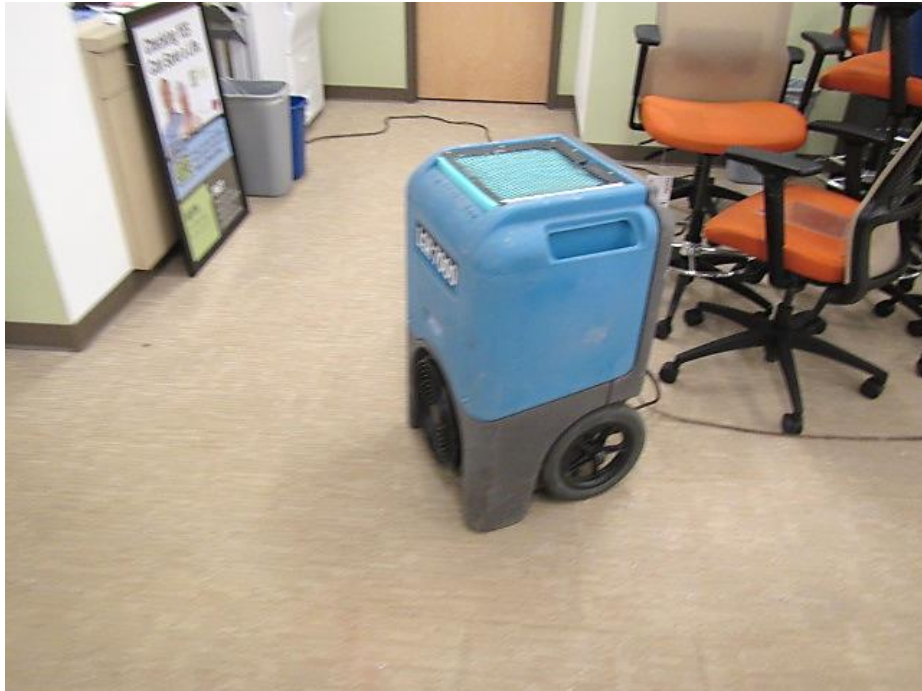
**Picture 5**

**Industrial air mover drying carpeting**

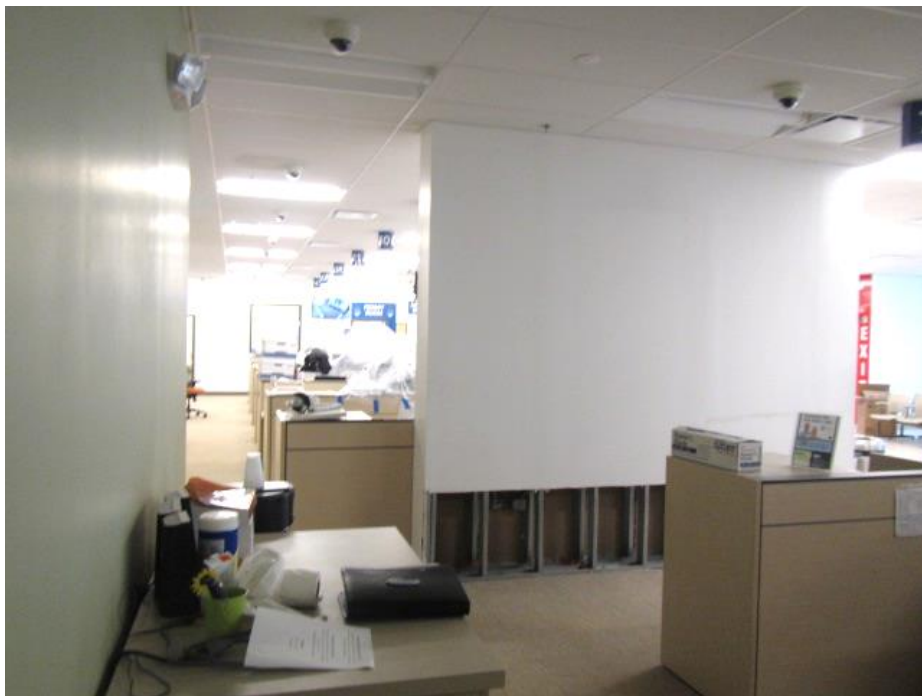
**Picture 6**

**Main area with drywall/insulation removed/carpet dried**

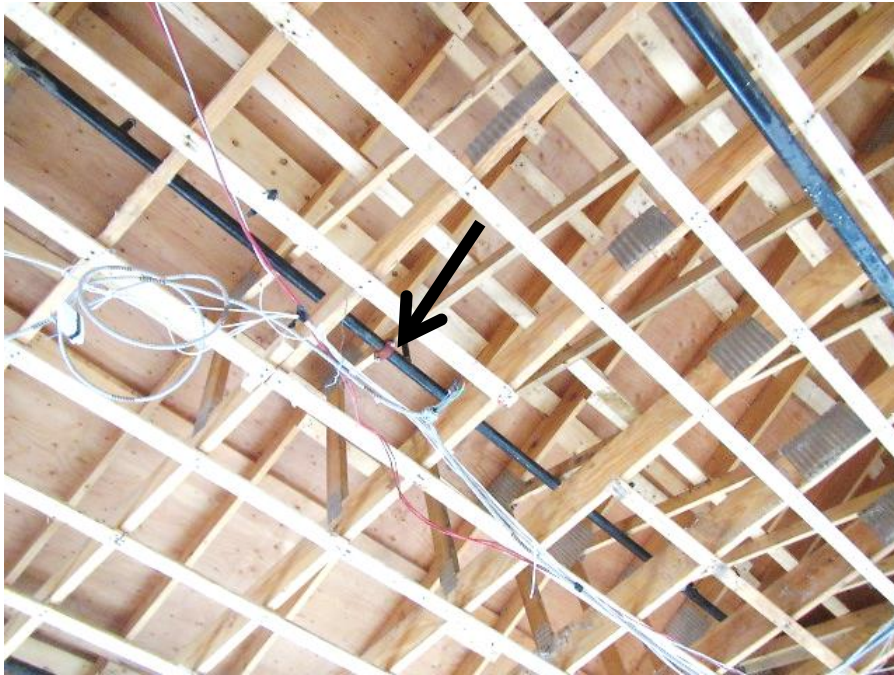
**Picture 7**

The BEH/IAQ Program was asked to examine the Brockton RMV office for the presence of water damage/mold growth, with a focus on areas that were damaged by a sprinkler pipe burst that occurred on Sunday January 19, 2020 due to freezing temperatures. The leak damaged gypsum wallboard (GW) ceilings/walls, insulation, and carpeting as well as electrical, communications, and smoke alarm systems, mainly in the east portion of the building.

**All water-damaged ceiling materials removed, arrow indicates area of pipe that froze causing the flooding (now repaired)**

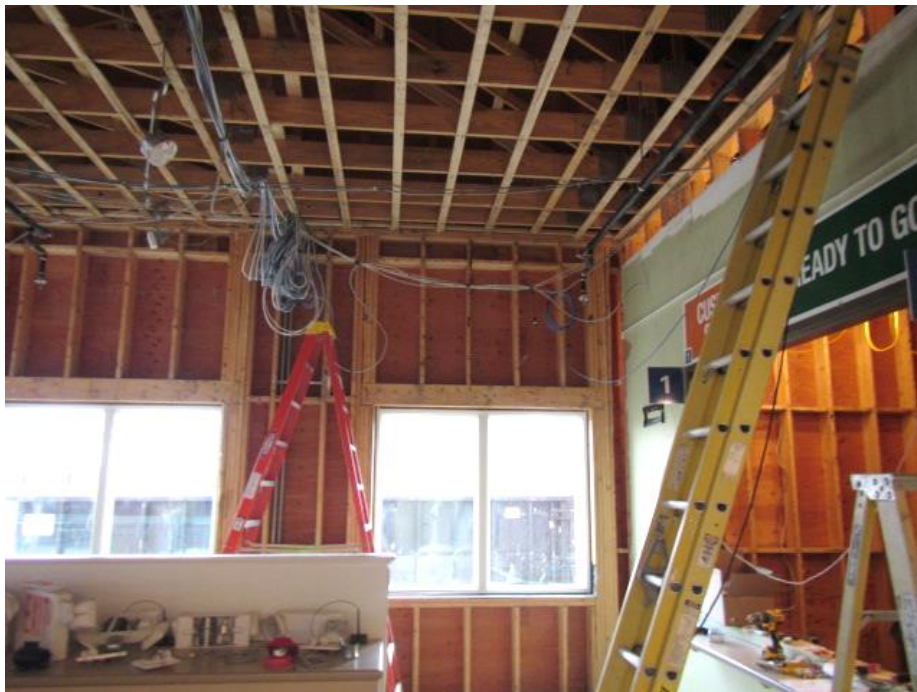
**Picture 8**

**All water-damaged ceiling/wall materials removed**

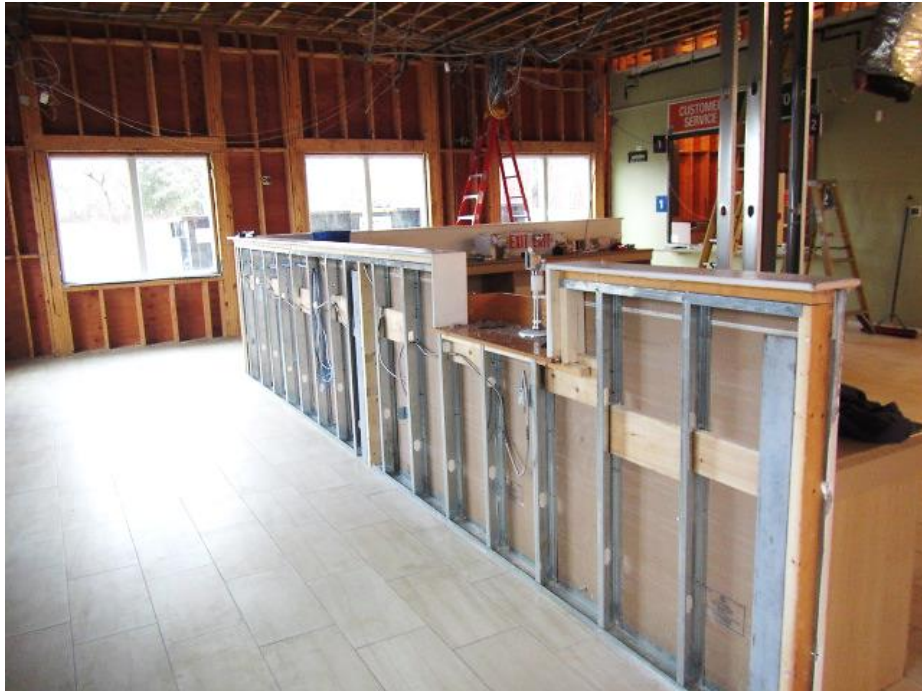
**Picture 9**

**All water-damaged ceiling/wall materials removed**

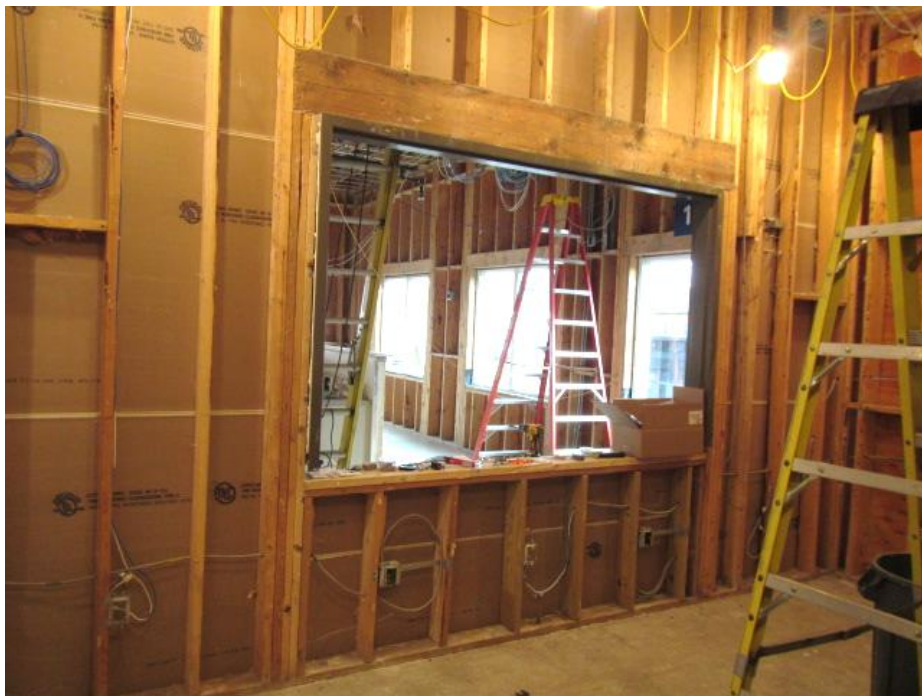
**Picture 10**

**All water-damaged ceiling/wall materials removed**
